**REPORT NUMBER: RED-05-01**

**REPORT ON EARLY DISTRESS (RED)  
RETROFIT DOWEL BARS on I-39**

**FINAL REPORT**

**JANUARY 2002**

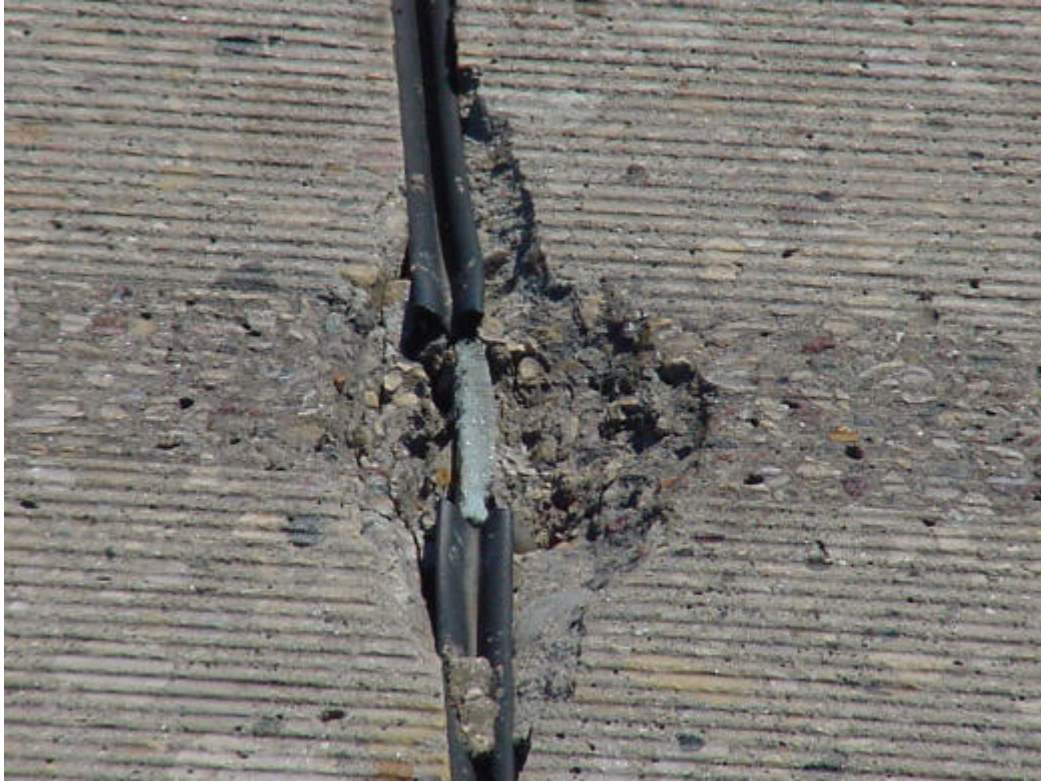
3. The primary distress (deterioration of the mortar in the dowel bar slots) appears to be causing secondary distress (spalling of the original concrete adjacent to the slots). When the mortar in the slots deteriorates at the joints, the adjacent concrete is left “hanging” and exposed, and when combined with subsequent traffic loadings, appear to be causing spalling of the original concrete.

Print 1. Close-up of the deterioration of the mortar at the joint. Notice the secondary distress in the form of spalling of the original concrete adjacent to the dowel bar slot.

1. Rehabilitate the worst performing sections on I-39 during summer of 2001 with a 3 ½" hot mix asphalt overlay.
2. Perform preventative maintenance by resealing the joints and spraying silane-based sealer on all exposed surfaces of the mortar material to limit future water intrusion into the joint and into the mortar material itself. Slots with deteriorated mortar should be sandblasted to remove the distressed material and refilled with mortar prior to being sealed.

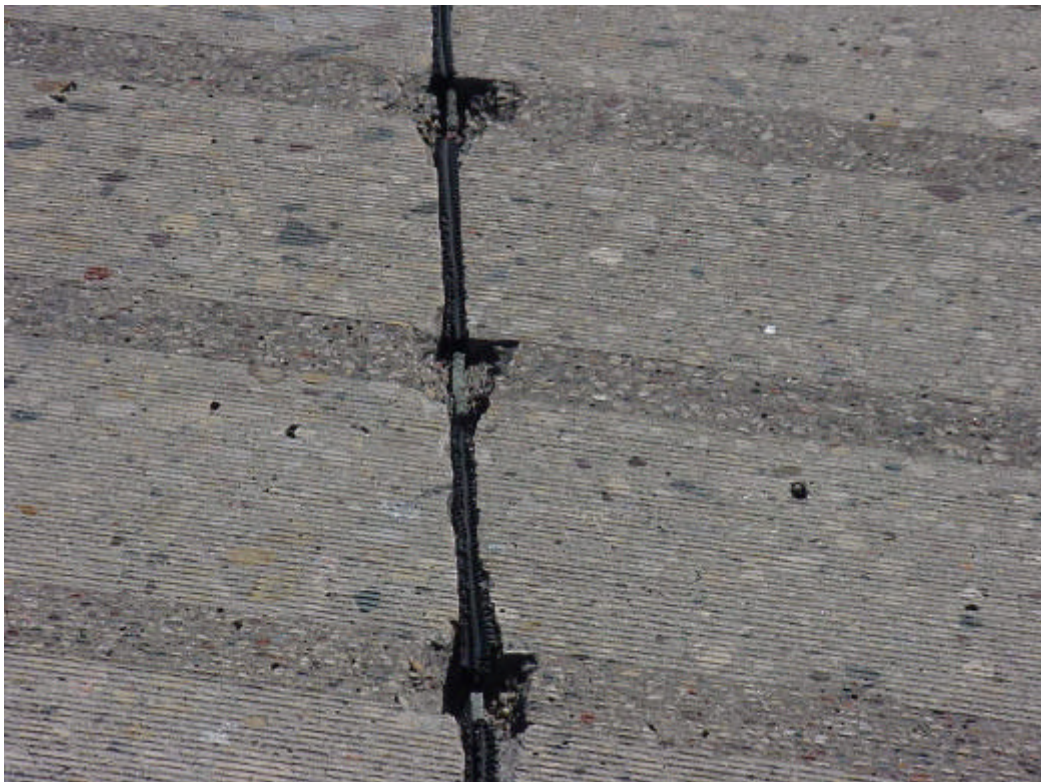
Print 2. Mortar loss and some slight spalling of the original concrete adjacent to the dowel bar slots.

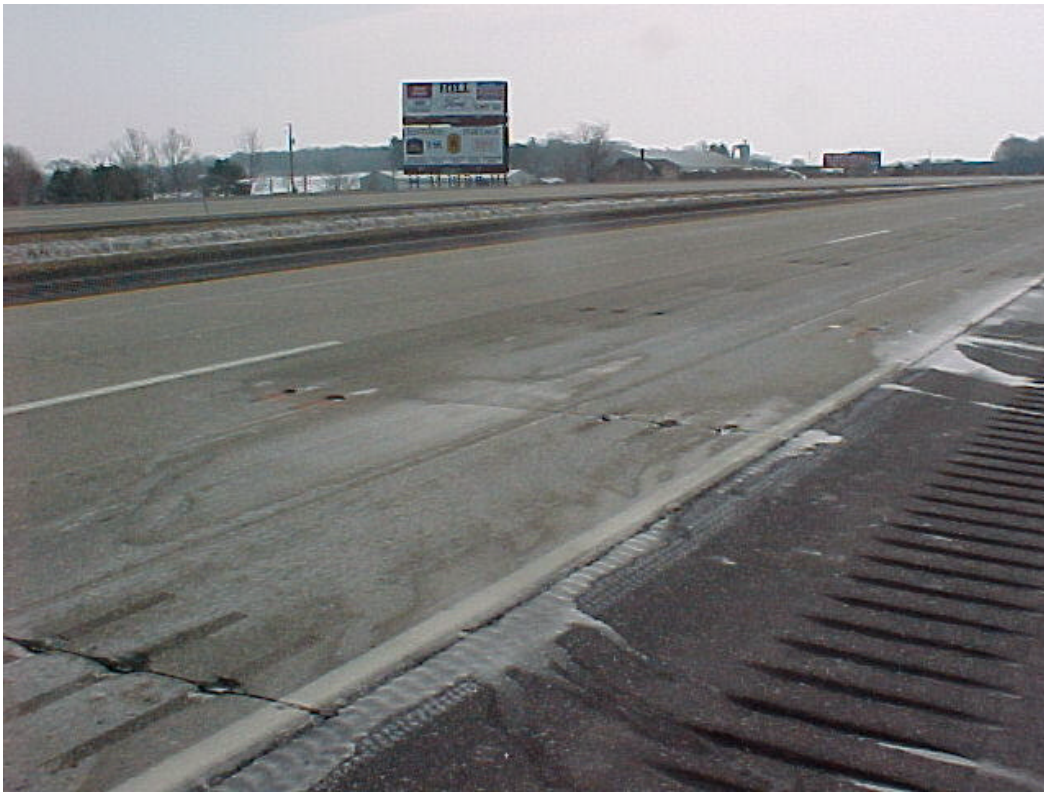
Print 3. An area of severe deterioration of the mortar at the joints on I-39.

2. Primary cause of distress appears to be lack of freeze/thaw durability of the proprietary mortar mixes. The distress or deterioration of the mortar starts at the joint and work its way out in a series of concentric arcs growing deeper and widening out from the joint as the deterioration advances. Scaling of the mortar surface is also evident in various areas. The surface loss due to scaling is approximately 1/16 in. – 1/8 in. (as of June, 2001).

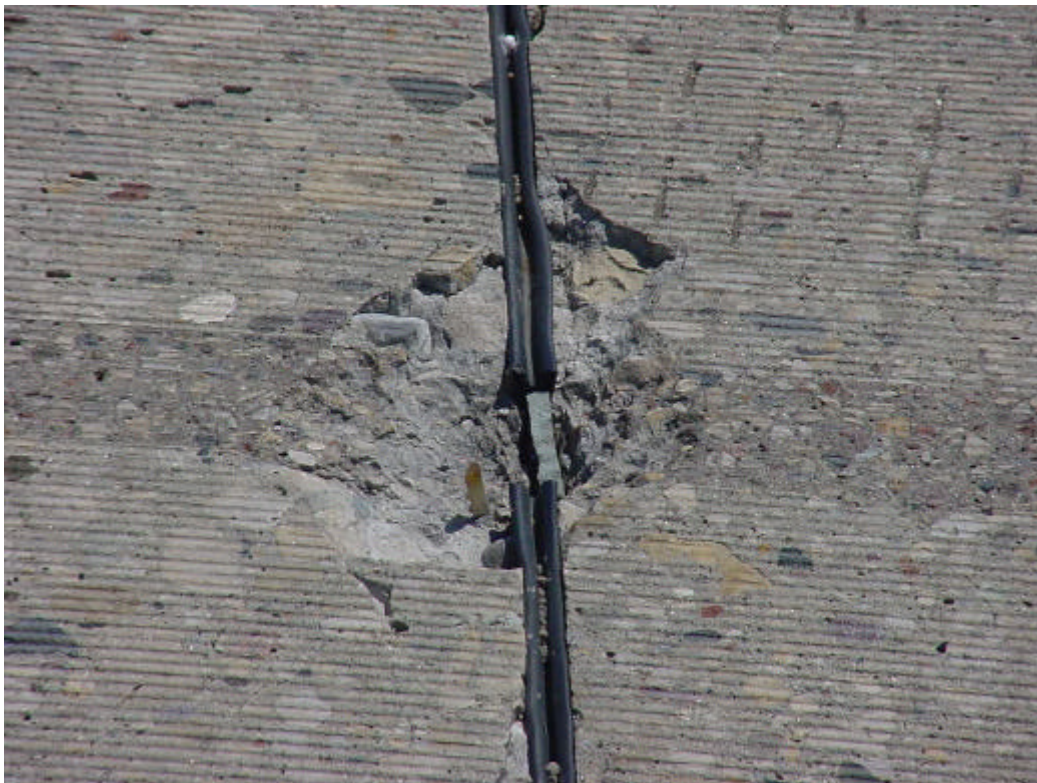
Print 4. Mortar deterioration at the joint and secondary spalling distress on I-39.

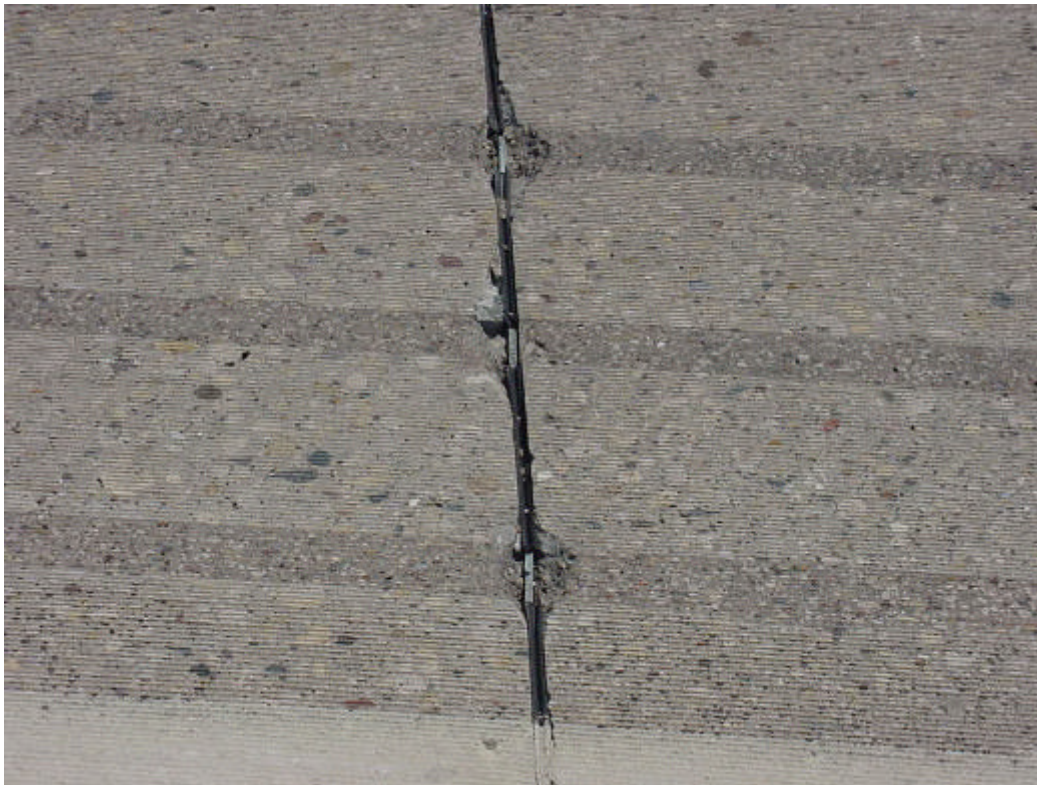
Print 5. Mortar deterioration and associated spalling on I-39. Photo taken July 9, 2001.

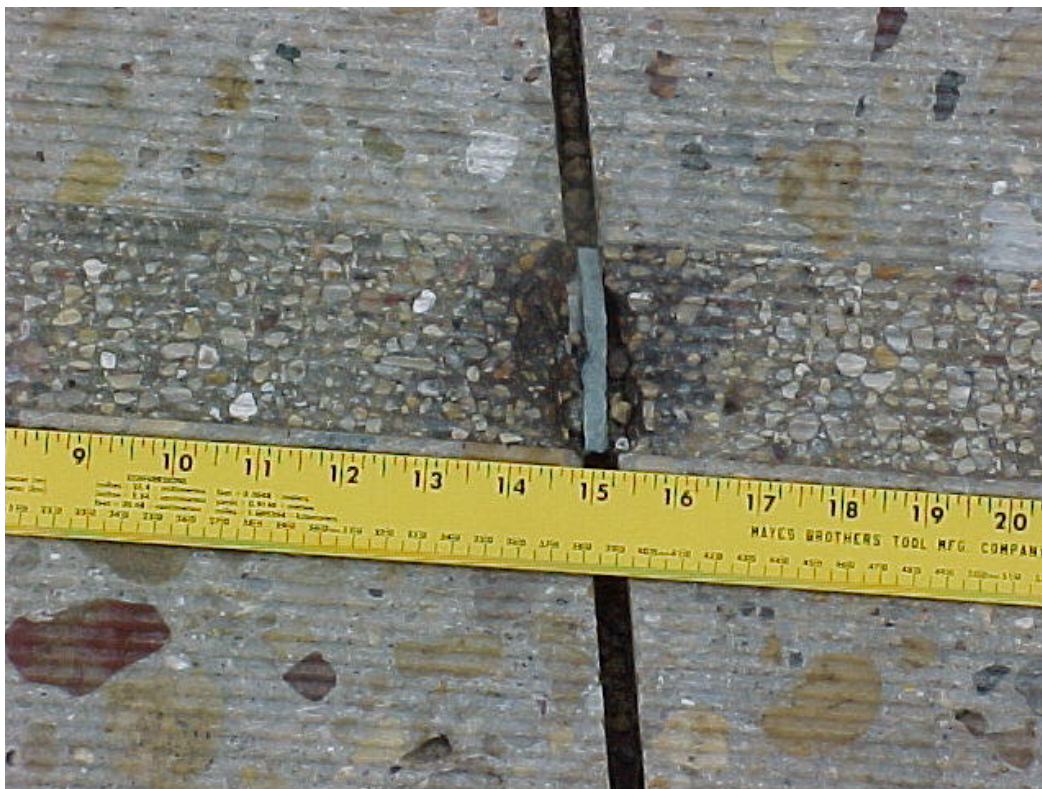
8. The foam boards are holding water, perhaps accelerating the deterioration of the mortar.
9. It was noticed on the STH 13 project that the caulk used to keep the foam boards in place and prevent mortar from flowing into the joints was a siliconized acrylic sealant (RCS20) made by the General Electric Company. This product is water-soluble and as such, the possibility exists that the water in the mortar mix may have dissolved the caulk and allowed for intrusion of the mortar into the joints. WisDOT specifications call for a silicon sealant to be used (different than a “siliconized”, acrylic, water-based sealant).

Print 6. Deterioration of the mortar material originating at the joint on US 61.  
Notice the stained area near the joint is still holding moisture a couple days after a rain event.

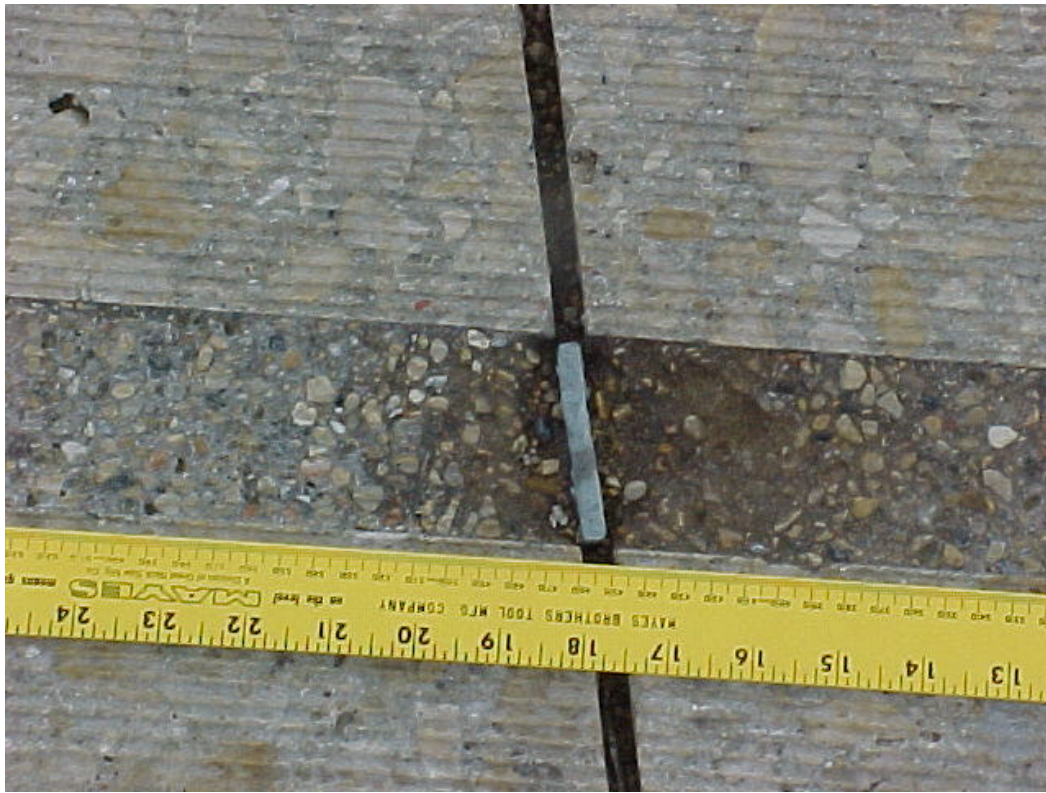
Print 7. Deterioration and slight scaling of the mortar material. Again, notice the stained area near the joint is still holding moisture a couple days after a rain event.

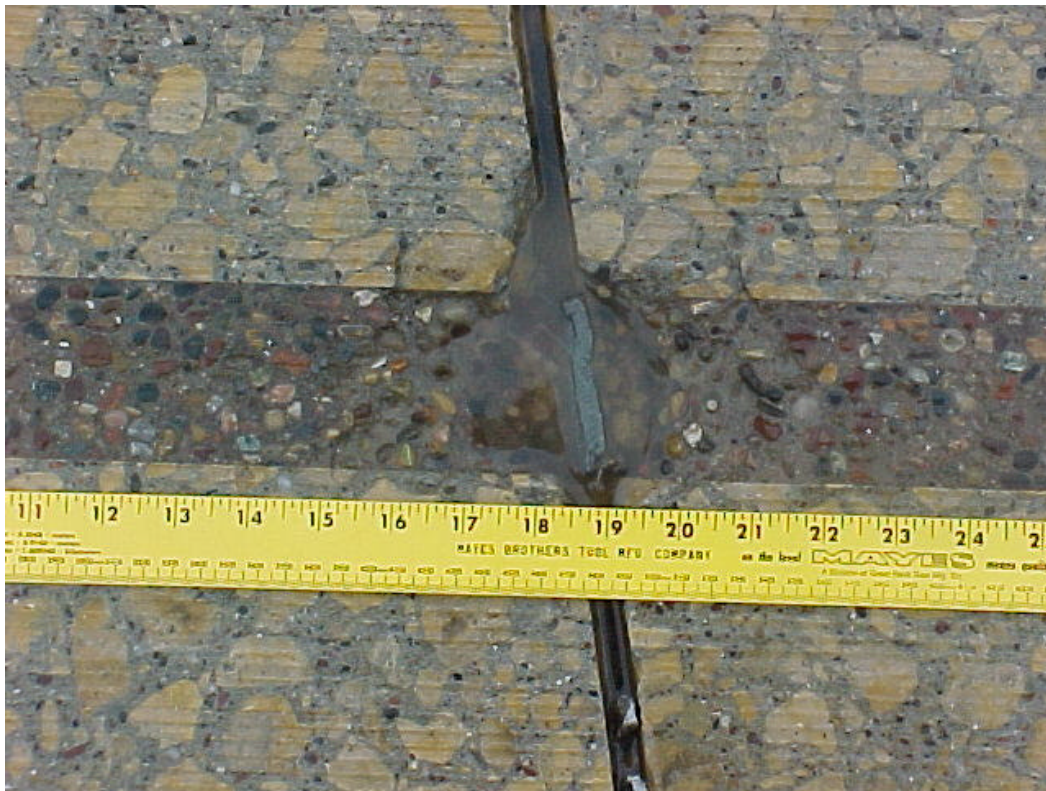
Print 8. View of water ponding in the slot on US 61. Also notice the spalling of the original concrete.

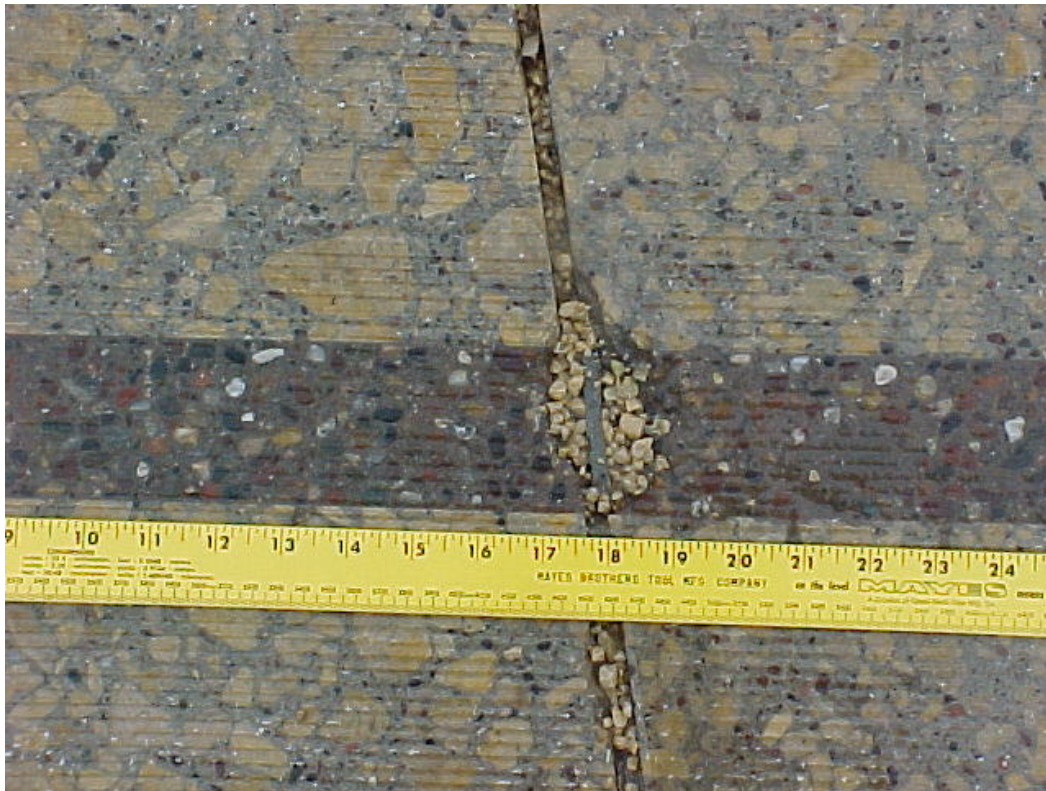
Print 9. Disintegration of the mortar material on US 61.

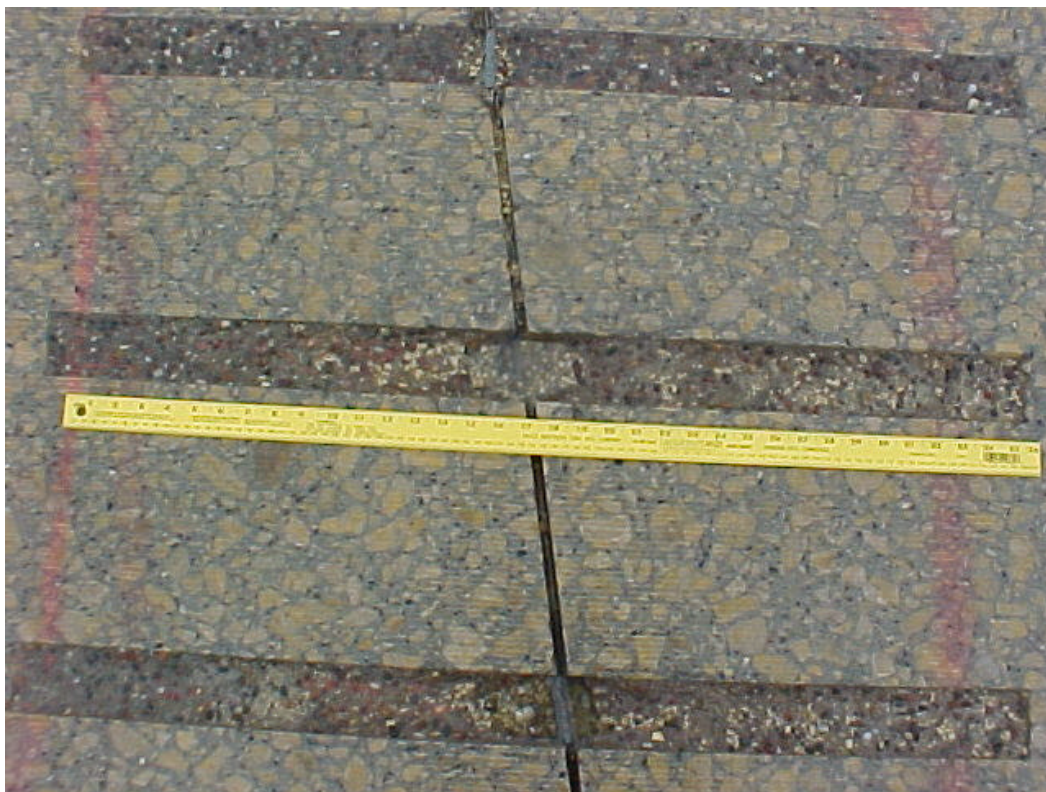
Print 10. Mortar deterioration and moderate scaling on US 61.
